**Disability Inclusive
Disaster Risk Reduction Initiatives of the
CBM Nepal Country Office**

**A REPORT ON STRUCTURAL AND NON-
STRUCTURAL RISK ASSESSMENT OF
HRDC NEPAL**

January 12, 2018

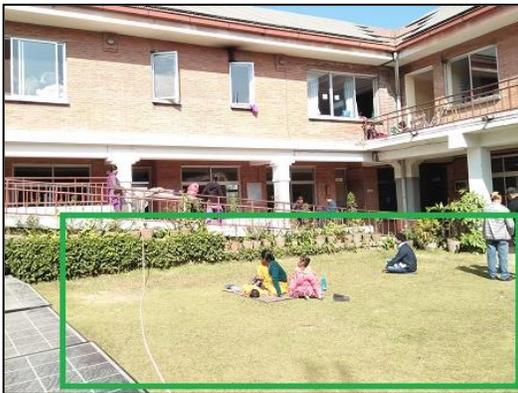
Approximately 30% of the land consists of open and unused areas, which is not

adequate when compared to the daily flow of patients and visitors. The open space currently used for gardening is suitable to be used as 'safe' area for some of the blocks. The open area inside the OPD building is relatively safe when compared to the open areas on the sides and behind. However, the ratio of open space to the occupancy and daily flow is not adequate.

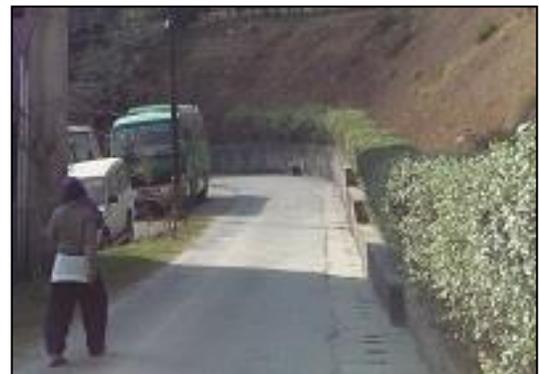
The hospital has provisioned the same entrance and exit gate in the North-eastern side of the compound. This main gate is sufficiently wide to allow entry and exit of ambulance and fire engine in case of emergency. However, it is not wide enough to allow passage of multiple and large number of rescue vehicles at the same time. It even acts as a bottleneck to the easy movement of hospital patients when the flow is high. Hence, the single gate is not appropriate for emergency situations.

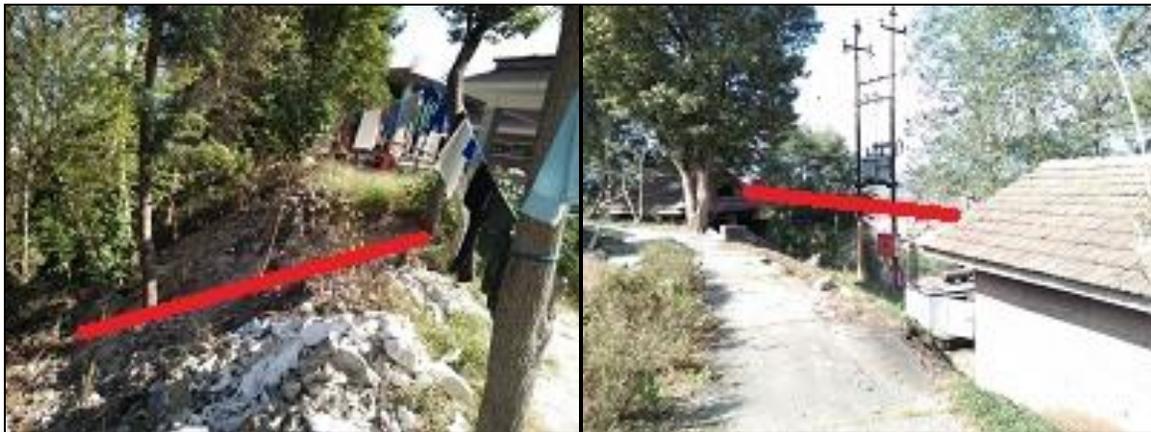
The hospital surroundings comprise a public road, jungle, jungle and human settlement respectively in East, North, West and Southern part of the used areas. Bushes are found in the East and West sides of the hospital. The construction materials stored temporarily on the way to the hospital may create obstacles to free movement and emergency evacuation. It would be wise to prohibit patient movement in the Western side due to more than 30 degrees landslide-prone slopes – it may be suggested that bio-engineering and gabion boxes be used to improve the stability of this area. The close proximity observed between the generator (alternative power supply) rooms, the fuel storage room and waste management (burning) house, coupled with the location of electric transformer between these rooms could easily contribute to a major fire hazard in this area. The main hazards in the hospital vicinity are therefore landslide, fire, earthquake and windstorm.

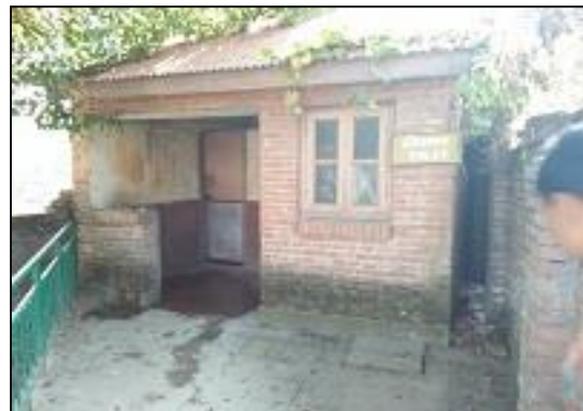
As the hospital is situated on the top of a hill, there isn't any major problem with drainage facilities. Rain water is properly channelized towards lower land. The waste management system also seems well managed, except in the western slopes where used medical materials have been randomly stored. The assessors did not find any hazardous materials stored or located in any area without having any warning signs.

However, improvements to WASH facilities, and structural strengthening of the public latrine as well as making it accessible for all should be highly prioritized.
